## United Church Bradford on Avon

### General Risk Assessment

Premises	United Church Bradford on Avon	Date of Review	25 <sup>th</sup> April 2025
Address	10 St Margaret's Street Bradford on Avon Wiltshire BA15 1DD	Reviewed by	Roy Short
Date Issued	06/05/2022		
Next Review Due	This risk assessment and other relevant health and safety documents will be reviewed at least annually or earlier if necessary in the event of a reported hazard or of an accident or incident that requires a review or change of arrangements.		
<p>An inspection of the buildings was carried out in general following the guidelines set out in the Methodist Church document: Risk Assessment for Small Churches.</p> <p>Section 1 of this risk assessment contains general health and safety management notes and section 2 contains the risk assessment of various hazards observed.</p> <p>The buildings are well maintained and regular cleaning is carried out.</p>

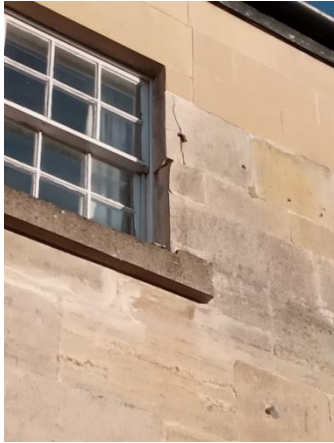
Haz 12	Bolted door from basement on Hall side preventing use of door from Basement. Risk of trapping in basement area – note fire escape exists in Basement.				Basement users	Consider in context of Fire Risk Assessment.			
Haz 13	Damaged / cracked stone ashlar to right hand first floor window reveal viewed from outside car park. Danger of stone becoming dislodged falling and striking someone below	4	5	20	Car Park users	Repair stonework to window reveal by cutting out damaged section and fix new stone to make good window reveal.			0
	H&S Law Poster?					Check RS – In place on noticeboard.			
HAZ 14	Loose masonry top course of boundary wall.	3	5	15		Remove and re-bed top course of wall.			0

Haz 8	Refer to Note 12.	Roy Short & Geraint Owen	Grit available in grit box on corner of front car park.
Haz 9	Guard rails being made.	Roy Short & Geraint Owen	Complete
Haz 10 & 11	Arrangements for removal of build-up of waste in hand and rodent eradication.	Geraint Owen	Complete.
Haz 12	Consider as part of FRA review. Review / replace existing ironmongery.	Roy Short & Geraint Owen.	Under action, review as part of FRA review.  Bolt removed from door.
Haz 13	To be dealt with as part of the planned maintenance programme, scaffolding permission required.	Geraint Owen	Under action (loose stone removed)
H&S Law Poster	Provide and fix.	Roy Short	Complete 15/05/21, see Section 4 signage.
