Reinspection Survey For

Woodbastwick Village Hall, Salhouse Road, Woodbastwick, Norwich, Norfolk, NR13 6HQ

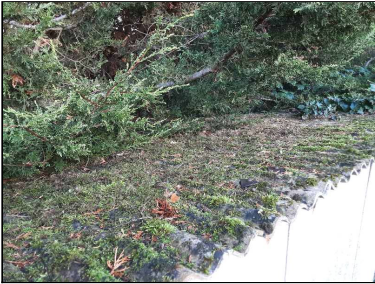
| | 1 | SA003979* (S) | Asbestos Cement (1) | Surface Sealed (1) | Low Damage (1) | Occasionally likely to be disturbed | |
| Surveyor comments | | No changes or deterioration observed. The roof sheets are weathered externally & are extensively covered with moss. The sheets are in fair condition excluding localised areas of minor damage to the edges of some boards & no obvious delamination was observed although this was inherently difficult to observe due to the extensive moss growth. Note, limited access to the rear of the building did not identify any obvious areas of loose moss debris to ground. It should however be duly noted that should any moss debris to the rear elevation ground be found there is a possibility that it could be contaminated with asbestos. | | | | | |

| Recommended action | | Manage in Situ - Manage by ensuring anyone likely to disturb are made aware of the presence of asbestos, label (where practical) & undertake 12 monthly inspections for damage & deterioration (see Recommendations) | | | | | |

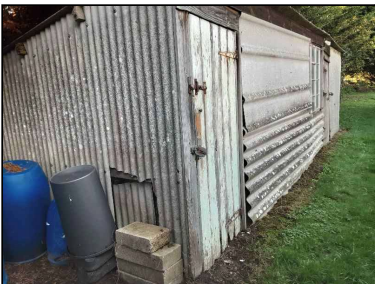
| | 2 | As SA003979* (SP) | Asbestos Cement (1) | Surface Sealed (1) | Medium Damage (2) | Occasionally likely to be disturbed | |
| Surveyor comments | | No changes observed. Entry comprises the small profile sheets, see photo & drawing for reference & orientation. The external side of the wall sheets are weathered & are in fair condition excluding localised areas of minor damage to the edges of some boards & an area of breakage to the low level Southwest side that has not deteriorated since the last inspection, see photo. | | | | | |

| Recommended action | | Manage in Situ - Manage by ensuring anyone likely to disturb are made aware of the presence of asbestos, label (where practical) & undertake 12 monthly inspections for damage & deterioration (see Recommendations) | | | | | |

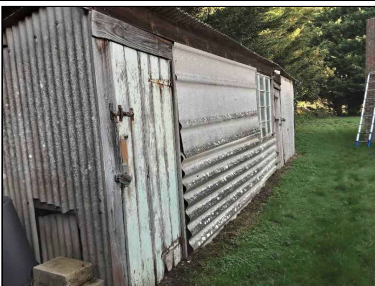
| | 3 | SA003980* (S) | Asbestos Cement (1) | Surface Sealed (1) | Low Damage (1) | Occasionally likely to be disturbed |
| Surveyor comments | | No changes or deterioration observed. Comprises a single sheet to the front elevation that is different to cement sheets 01 & 03 & was subsequently sampled independently. Weathered but in fair condition. | | | | |

| Recommended action | | Manage in Situ - Manage by ensuring anyone likely to disturb are made aware of the presence of asbestos, label (where practical) & undertake 12 monthly inspections for damage & deterioration (see Recommendations) | | | | |

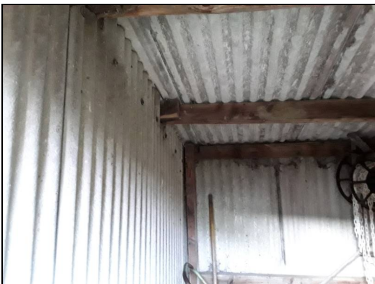
| Surveyor comments | | No inspection access as no key available. Upon undertaking the previous inspection, the rearside of the cement roof & wall boards were in fair condition. | | | | |

| Recommended action | | Manage in Situ - Manage by ensuring anyone likely to disturb are made aware of the presence of asbestos, label (where practical) & undertake 12 monthly inspections for damage & deterioration (see Recommendations) | | | | |

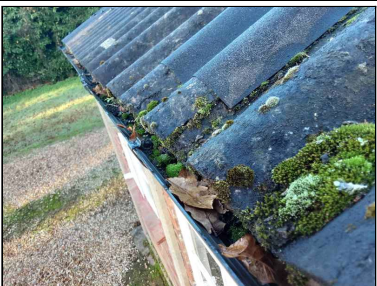
| Surveyor comments | | No changes or further deterioration observed. Upon localised & limited inspections, the areas of delamination do not appear to have not got any worse & are only present to a few localised areas. The remaining cement roof sheets are mostly intact & in fair condition & have been painted with a bitumen paint & have areas of patching & repairs. There is also an area to the north side of the roof that is covered with corrugated tin sheeting. Due to the evidence of patching & repairs & visible delaminated areas, it is recommended that the client considers removal & replacement in the longer term. Refer to Section 4 for general information regarding managing & maintaining asbestos cement products. | | | | |

| Recommended action | | Manage in Situ - Manage by ensuring anyone likely to disturb are made aware of the presence of asbestos, label (where practical) & undertake 12 monthly inspections for damage & deterioration (see Recommendations) | | | | |

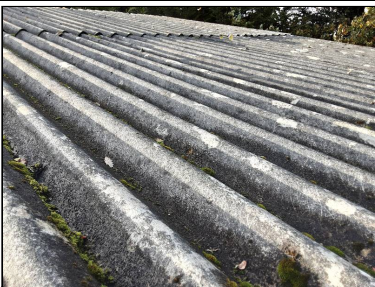
| Surveyor comments | | No changes or deterioration observed. The roof sheets are weathered & in fair condition & have light moss growth. | | | | |

| Recommended action | | Manage in Situ - Manage by ensuring anyone likely to disturb are made aware of the presence of asbestos, label (where practical) & undertake 12 monthly inspections for damage & deterioration (see Recommendations) | | | | |

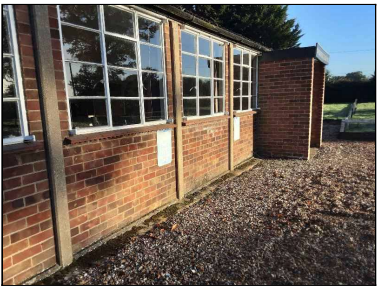
| Surveyor comments | | No changes. Unable to access the window fittings & determine the composition of any window packing without completely removing the window. It is known that asbestos insulating board was occasionally used as a convenient packing material to level Critical windows & doors & Chrysotile asbestos was also used as plug material for window & door fixings. Any asbestos materials will not be apparent until the windows & doors are removed. | | | | |

| Recommended action | | Presume Asbestos Present - HSG 264 survey protocols dictate that any areas/items where inspection access was not obtained must (by default) be presumed to contain asbestos until definitively proven otherwise | | | | |

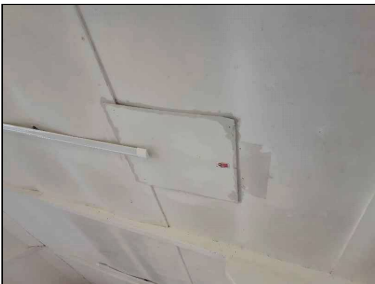
| Surveyor comments | | <p>Insulating board panel P1, (see drawing) has been encapsulated/sealed with paint & an asbestos warning label has been applied. There is a slight area of breakage to the corner which is sealed & is secure, i.e. not loose. Asbestos Insulating Board (AIB) is a low density, friable material. Working with this material, including encapsulation & repair must only be undertaken by a specialist licensed contractor. See Section 4 for further details.</p> | | | | |

| Recommended action | | <p>Manage in Situ - Manage by ensuring anyone likely to disturb are made aware of the presence of asbestos, label (where practical) & undertake 12 monthly inspections for damage & deterioration (see Recommendations)</p> | | | | |

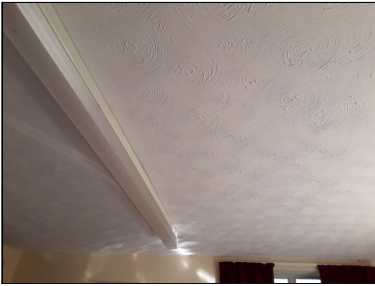
| Surveyor comments | | The textured coatings to the ceilings within locations: G5a & G6a were deemed to be of the same composition. Subsequent representative sample/scrapings from both areas were included in the sample bag submitted for analysis to ensure a definitive & accurate result. | | | | |

| Recommended action | | No further action required | | | | |

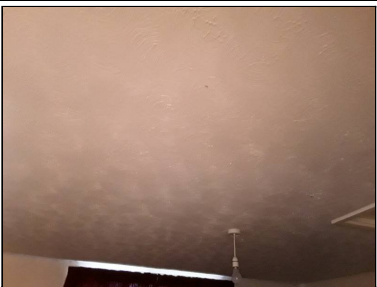
| Surveyor comments | | The textured coatings to the ceilings within locations: G5a & G6a were deemed to be of the same composition. Subsequent representative sample/scrapings from both areas were included in the sample bag submitted for analysis to ensure a definitive & accurate result. | | | | |

| Recommended action | | No further action required | | | | |

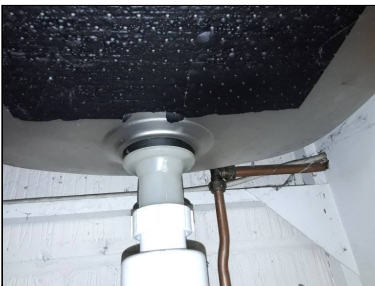
| Surveyor comments | | Mostly intact, edges have started to peel. Monitor condition. | | | | |

| Recommended action | | No further action required | | | | |

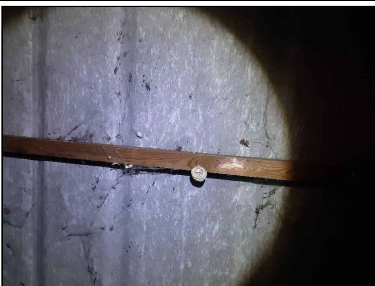
| Surveyor comments | | <p>Limited inspection, no changes observed. The underside of the cement roof sheets are in fair condition.</p> | | | | |

| Recommended action | | <p>Manage in Situ - Manage by ensuring anyone likely to disturb are made aware of the presence of asbestos, label (where practical) & undertake 12 monthly inspections for damage & deterioration (see Recommendations)</p> | | | | |

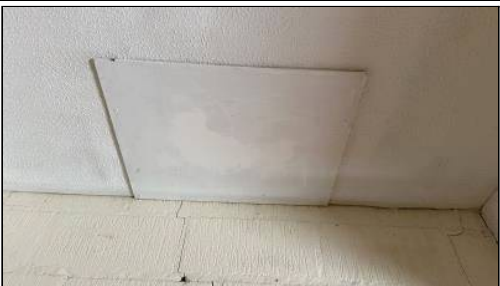
| Surveyor comments | | Not Previously identified. Supalux board is a modern low density fireboard that can be recognised by the presence of reflective mica within the board that is not present within asbestos insulating board (AIB). | | | | |

| Recommended action | | No further action required | | | | |

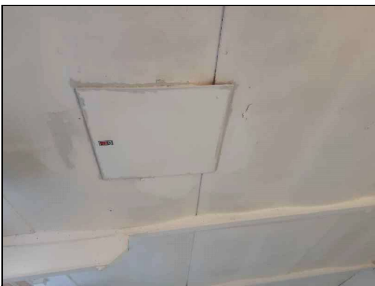
| Surveyor comments | | Insulating board panel P3, (see drawing) has been encapsulated/sealed with paint & an asbestos warning label has been applied. There is a slight gap at the top corner of the board which upon inspection was found to be secure, i.e. not loose. Asbestos Insulating Board (AIB) is a low density, friable material. Working with this material, including encapsulation & repair must only be undertaken by a specialist licensed contractor. See Section 4 for further details. | | | | |
