Reinspection Survey For

Woodbastwick Village Hall, Salhouse Road, Woodbastwick, Norwich, Norfolk, NR13 6HQ

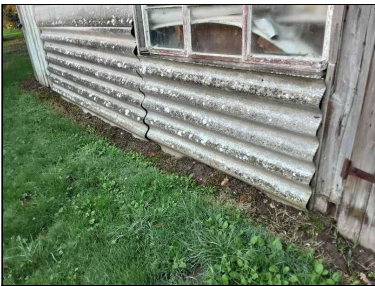
| Surveyor comments | | No changes or deterioration observed. Comprises a single sheet to the front elevation that is different to cement sheets 01 & 03 & was subsequently sampled independently. Weathered but in fair condition. | | | | |

| Recommended action | | Manage in Situ - Manage by ensuring anyone likely to disturb are made aware of the presence of asbestos, label (where practical) & undertake 12 monthly inspections for damage & deterioration (see Recommendations) | | | | |

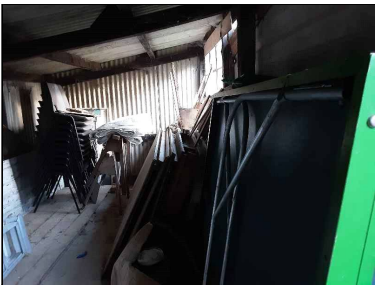
| Surveyor comments | | No inspection access as no key available. Upon undertaking the previous inspection, the rearside of the cement roof & wall boards were in fair condition. | | | | |

| Recommended action | | Manage in Situ - Manage by ensuring anyone likely to disturb are made aware of the presence of asbestos, label (where practical) & undertake 12 monthly inspections for damage & deterioration (see Recommendations) | | | | |

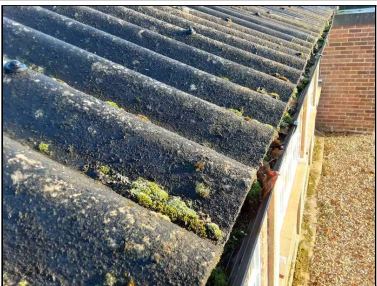
| Surveyor comments | | No changes or further deterioration observed. Upon localised & limited inspections, the areas of delamination do not appear to have not got any worse & are only present to a few localised areas. The remaining cement roof sheets are mostly intact & in fair condition & have been painted with a bitumen paint & have areas of patching & repairs. There is also an area to the north side of the roof that is covered with corrugated tin sheeting. Due to the evidence of patching & repairs & visible delaminated areas, it is recommended that the client considers removal & replacement in the longer term. Refer to Section 4 for general information regarding managing & maintaining asbestos cement products. | | | | |

| Recommended action | | Manage in Situ - Manage by ensuring anyone likely to disturb are made aware of the presence of asbestos, label (where practical) & undertake 12 monthly inspections for damage & deterioration (see Recommendations) | | | | |

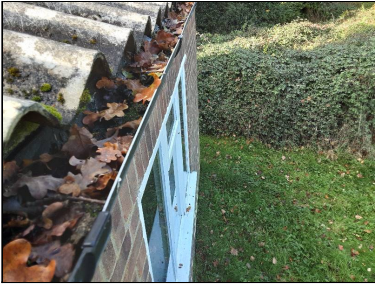
| Surveyor comments | | No changes or deterioration observed. The roof sheets are weathered & in fair condition & have light moss growth. | | | | |

| Recommended action | | Manage in Situ - Manage by ensuring anyone likely to disturb are made aware of the presence of asbestos, label (where practical) & undertake 12 monthly inspections for damage & deterioration (see Recommendations) | | | | |

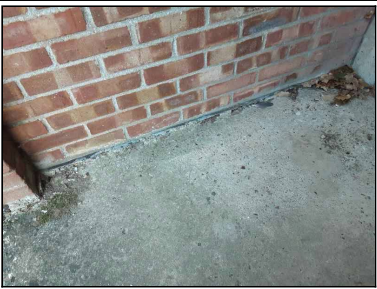
| Surveyor comments | | No changes. Unable to access the window fittings & determine the composition of any window packing without completely removing the window. It is known that asbestos insulating board was occasionally used as a convenient packing material to level Critical windows & doors & Chrysotile asbestos was also used as plug material for window & door fixings. Any asbestos materials will not be apparent until the windows & doors are removed. | | | | |

| Recommended action | | Presume Asbestos Present - HSG 264 survey protocols dictate that any areas/items where inspection access was not obtained must (by default) be presumed to contain asbestos until definitively proven otherwise | | | | |

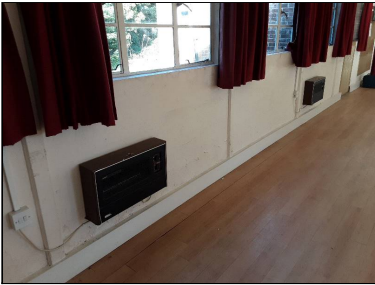
| Surveyor comments | | <p>Insulating board panel P1, (see drawing) has been encapsulated/sealed with paint & an asbestos warning label has been applied. There is a slight area of breakage to the corner which is sealed & is secure, i.e. not loose. Asbestos Insulating Board (AIB) is a low density, friable material. Working with this material, including encapsulation & repair must only be undertaken by a specialist licensed contractor. See Section 4 for further details.</p> | | | | |

| Recommended action | | <p>Manage in Situ - Manage by ensuring anyone likely to disturb are made aware of the presence of asbestos, label (where practical) & undertake 12 monthly inspections for damage & deterioration (see Recommendations)</p> | | | | |

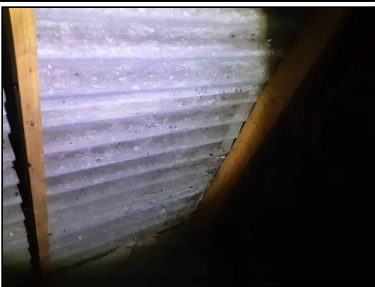
| Surveyor comments | | Mostly intact, edges have started to peel. Monitor condition. | | | | |

| Recommended action | | No further action required | | | | |

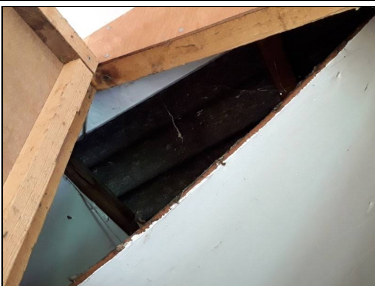
| Surveyor comments | | <p>Limited inspection, no changes observed. The underside of the cement roof sheets are in fair condition.</p> | | | | |

| Recommended action | | <p>Manage in Situ - Manage by ensuring anyone likely to disturb are made aware of the presence of asbestos, label (where practical) & undertake 12 monthly inspections for damage & deterioration (see Recommendations)</p> | | | | |

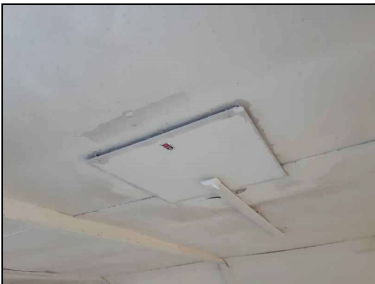
| Surveyor comments | | Not Previously identified. Supalux board is a modern low density fireboard that can be recognised by the presence of reflective mica within the board that is not present within asbestos insulating board (AIB). | | | | |

| Recommended action | | No further action required | | | | |

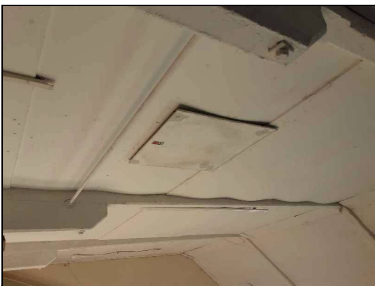
| Surveyor comments | | Insulating board panel P3, (see drawing) has been encapsulated/sealed with paint & an asbestos warning label has been applied. There is a slight gap at the top corner of the board which upon inspection was found to be secure, i.e. not loose. Asbestos Insulating Board (AIB) is a low density, friable material. Working with this material, including encapsulation & repair must only be undertaken by a specialist licensed contractor. See Section 4 for further details. | | | | |

| Recommended action | | Manage in Situ - Manage by ensuring anyone likely to disturb are made aware of the presence of asbestos, label (where practical) & undertake 12 monthly inspections for damage & deterioration (see Recommendations) | | | | |
